Photographic Log

Facility Name:		Site Location:	Project No.:
Park Avenue Hotel Group Tennessee LLC aka Athens Lodge, Red Roof Inn		115 CR-247 Athens, TN	TN0028886
Photo No.	Date

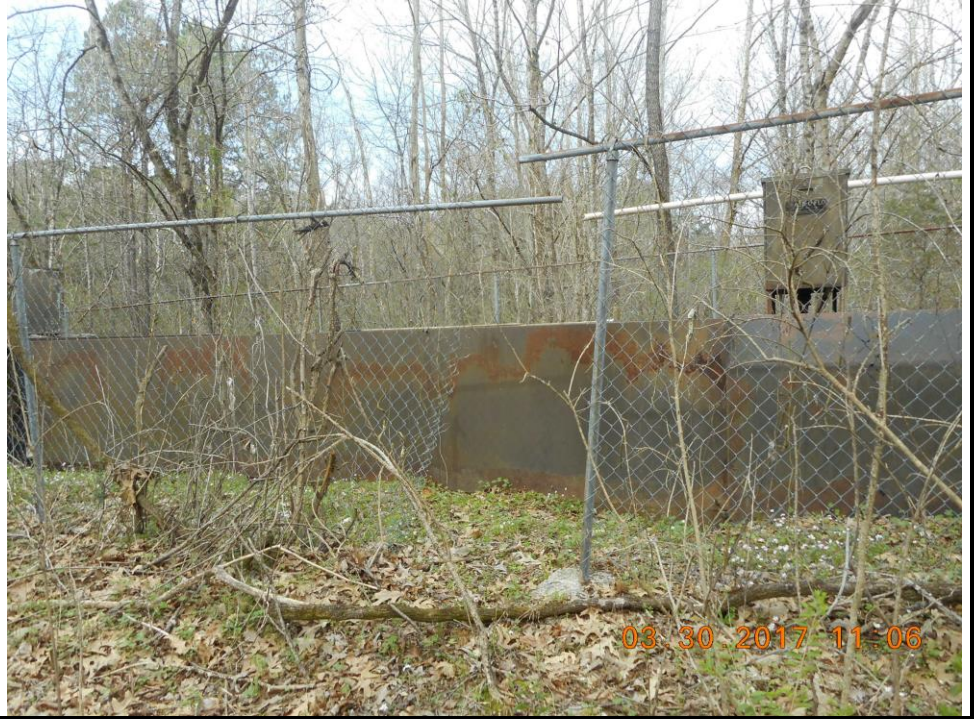
5	3-30-2017		
Description Breach in wastewater plant perimeter fencing. Photo taken from outside the perimeter fence on the east side of wastewater plant facing west.			
Photo No.	Date

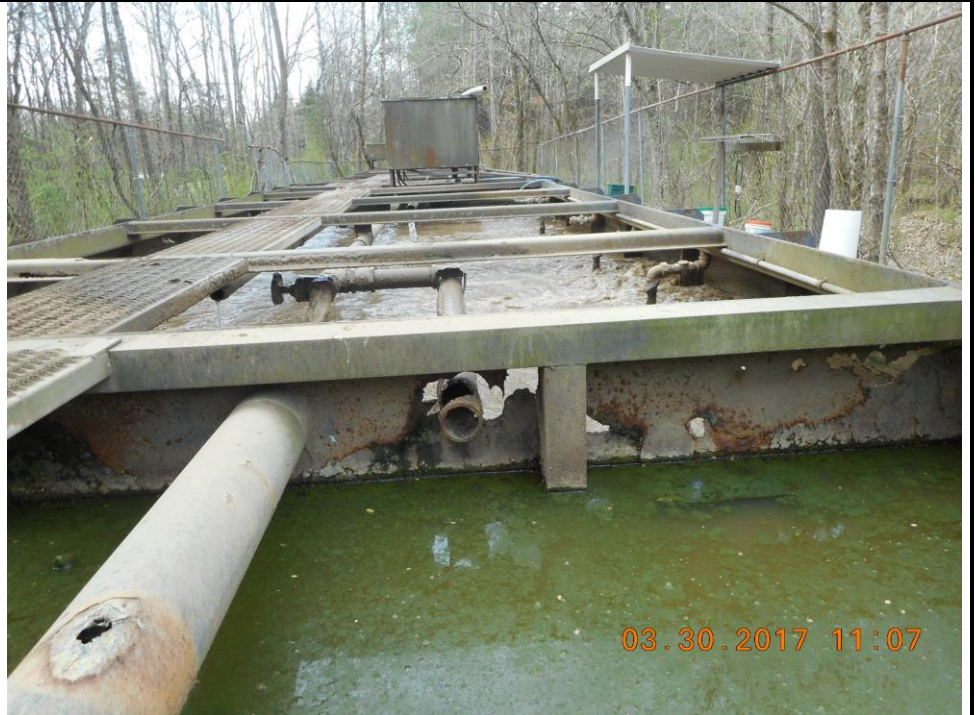
6	3-30-2017		
Description View of sludge basin/aeration basin divider wall and piping. Photo taken from inside the perimeter fencing facing south.

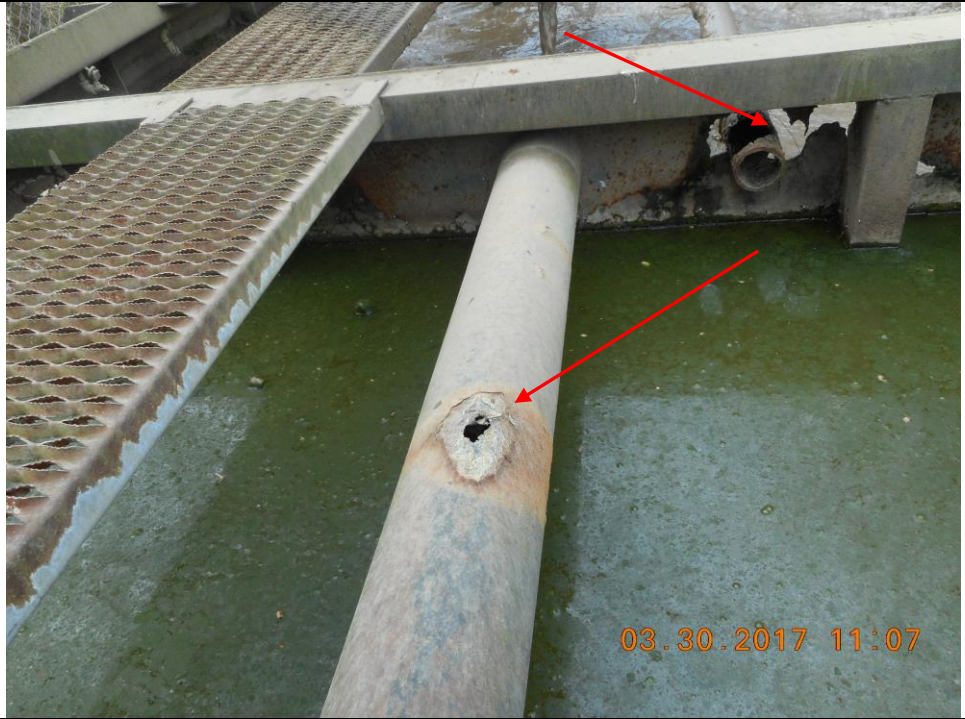
Facility Name: Park Avenue Hotel Group Tennessee LLC aka Athens Lodge, Red Roof Inn		Site Location: 115 CR-247 Athens, TN	Project No.: TN0028886
Photo No. 7	Date 3-30-2017

Description Closer view of sludge basin/aeration basin wall and piping to show deterioration of structure piping and basin walls indicated by red arrows.

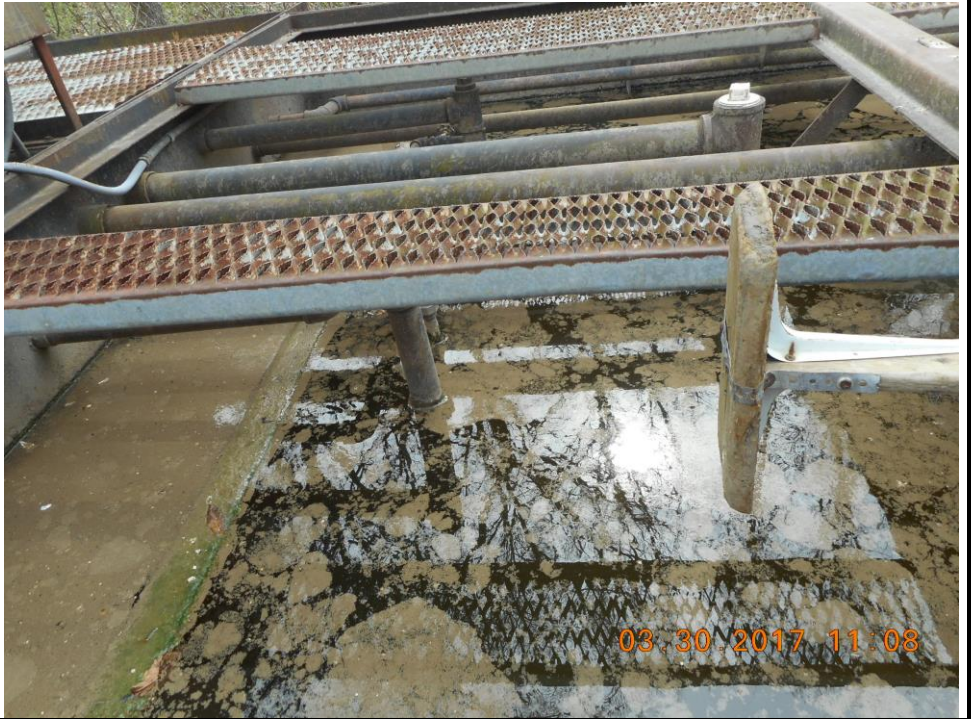
Description Clarifier basin with visible floating solids. The photo was taken from inside the perimeter fencing from the west side of the basin facing east.			
Photo No.	Date	Insert	
10	3-30-2017

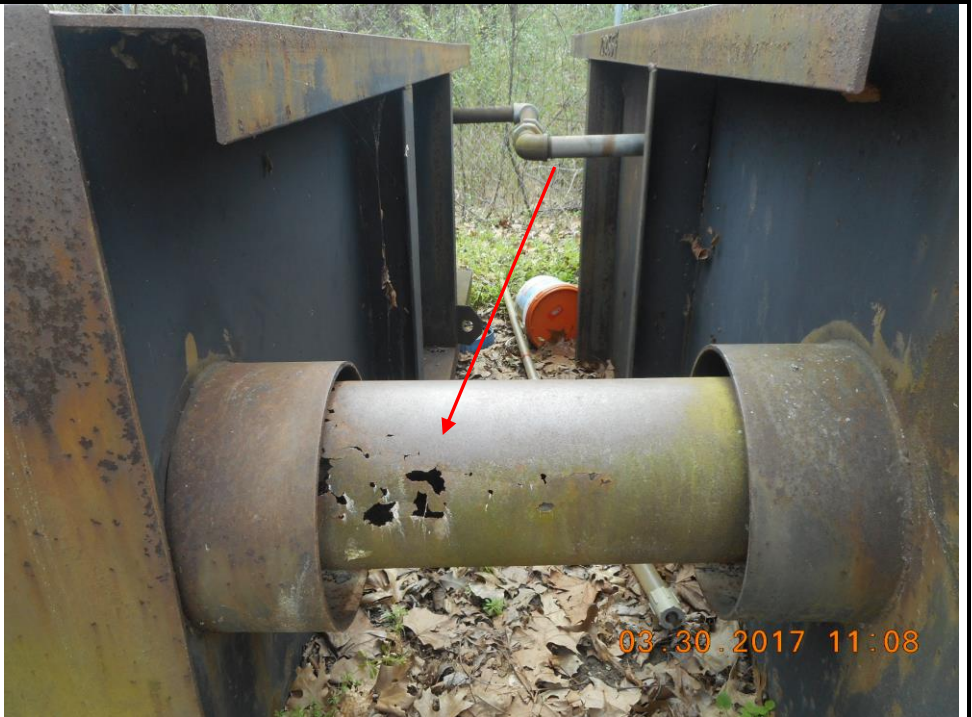
Description Deterioration of piping between clarifier basin and chlorine contact chamber basin indicated by red arrow. Photo taken from within the perimeter fencing on west side of the basin facing east.

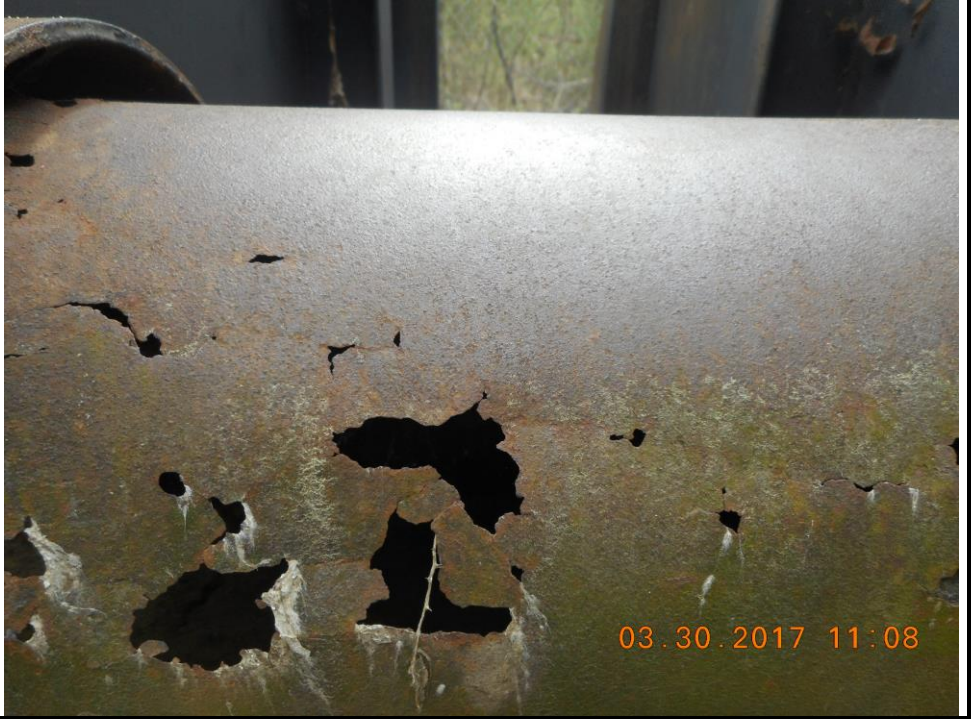
Facility Name:		Site Location:	Project No.:
Park Avenue Hotel Group Tennessee LLC aka Athens Lodge, Red Roof Inn		115 CR-247 Athens, TN	TN0028886
Photo No.	Date		
11	3-30-2017		
Description Closer view of deterioration of piping between clarifier basin and chlorine contact chamber basin. Photo taken from within the perimeter fencing on west side of the basin facing east.

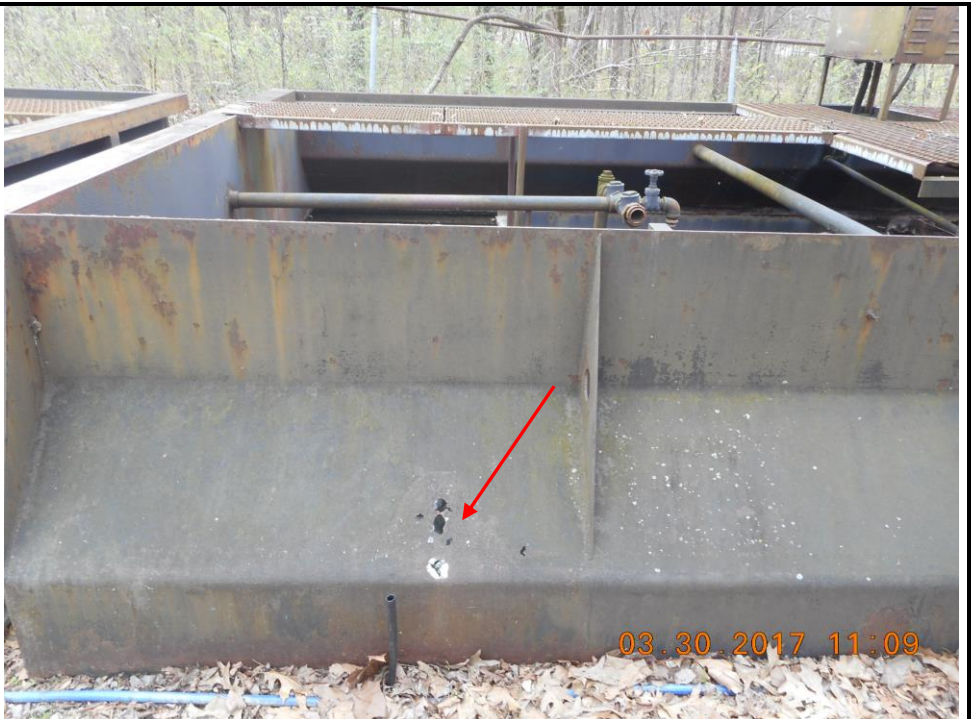
Photo No.	Date		
12	3-30-2017		
Description Deterioration of outer wall of chlorine contact chamber basin indicated by red arrow. Photo taken from within the perimeter fencing on west side of the basin facing east.

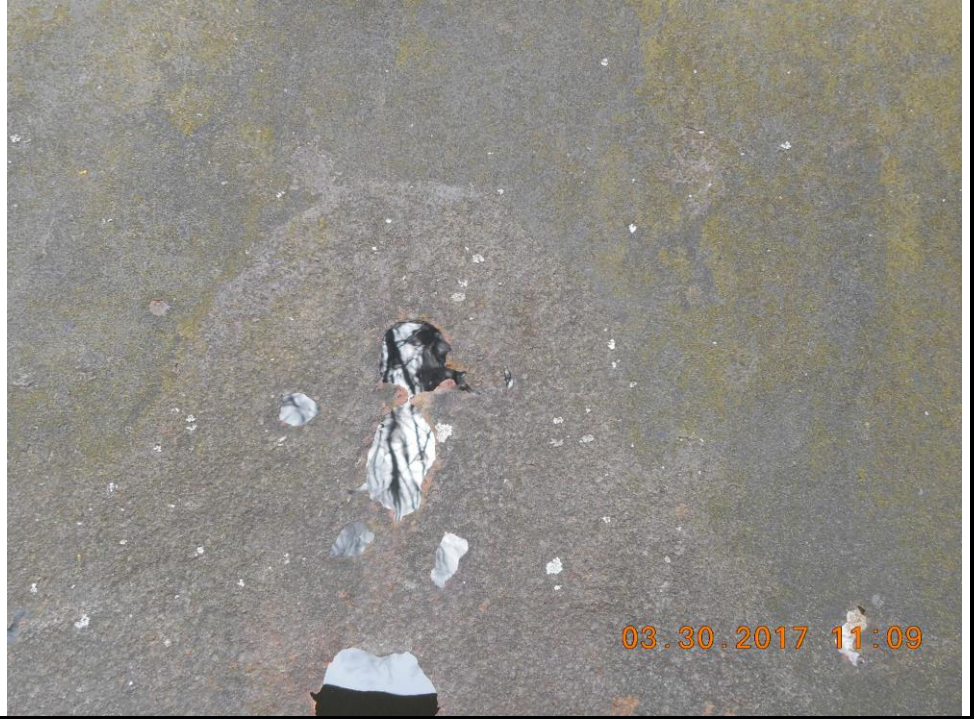
13	3-30-2017		
Description Closer view of deterioration of the outer wall of chlorine contact chamber basin. Photo taken from within the perimeter fencing on west side of the basin facing east.			
Photo No.	Date

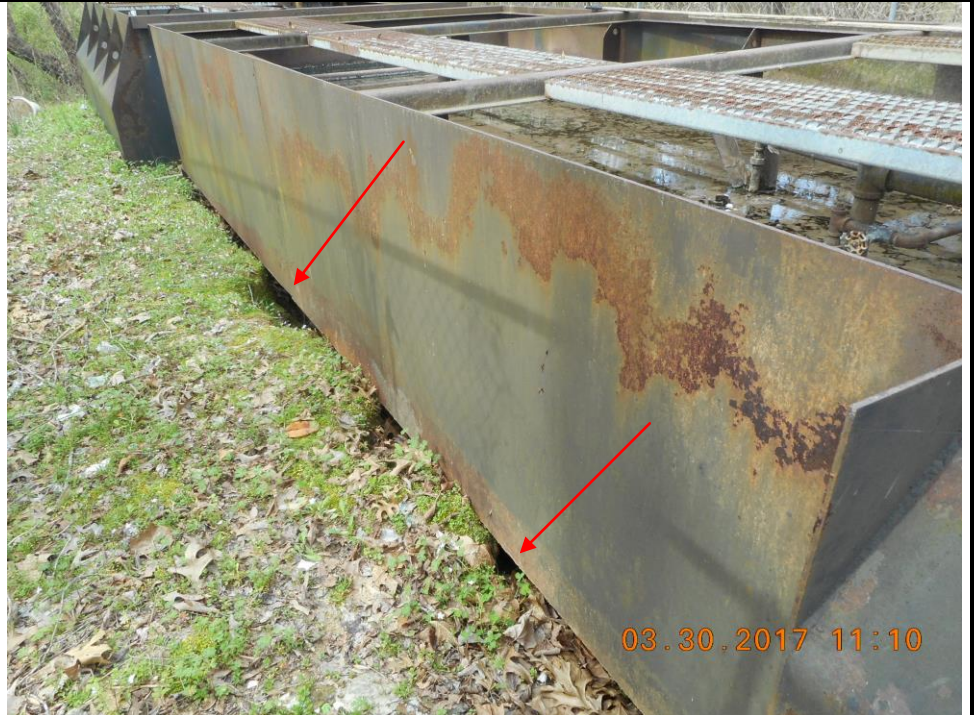
14	3-30-2017		
Description East wall of clarifier basin. Soil is eroded under the basin indicated by red arrows. Photo taken from inside perimeter fencing facing southwest.

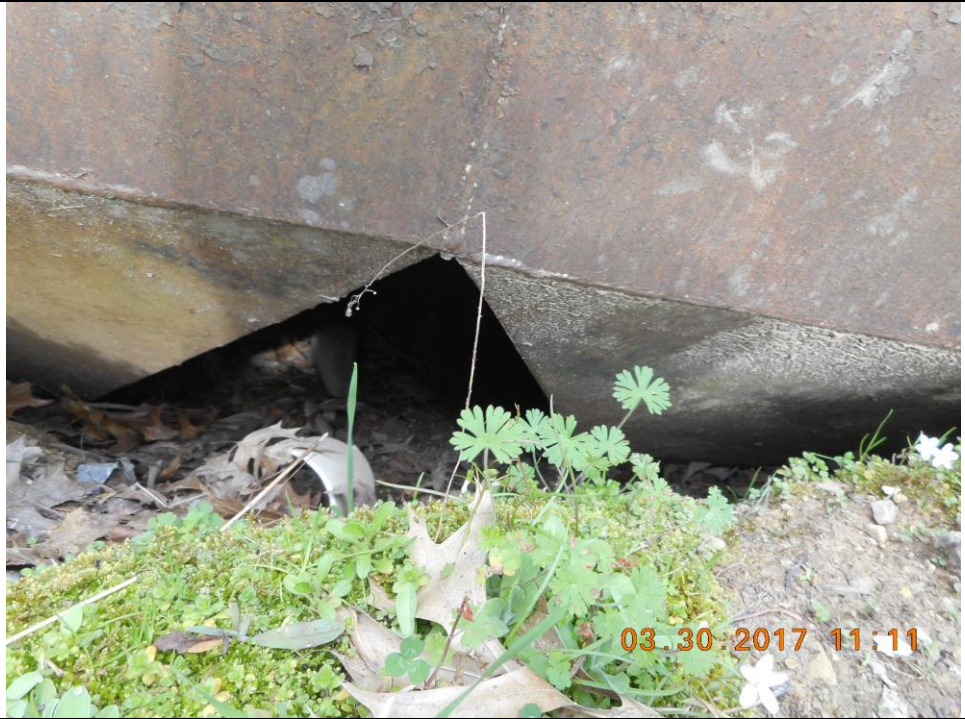
15	3-30-2017		
Description Close up of eroded areas under the wall of clarifier basin. Photo taken from inside perimeter fencing from east facing west.

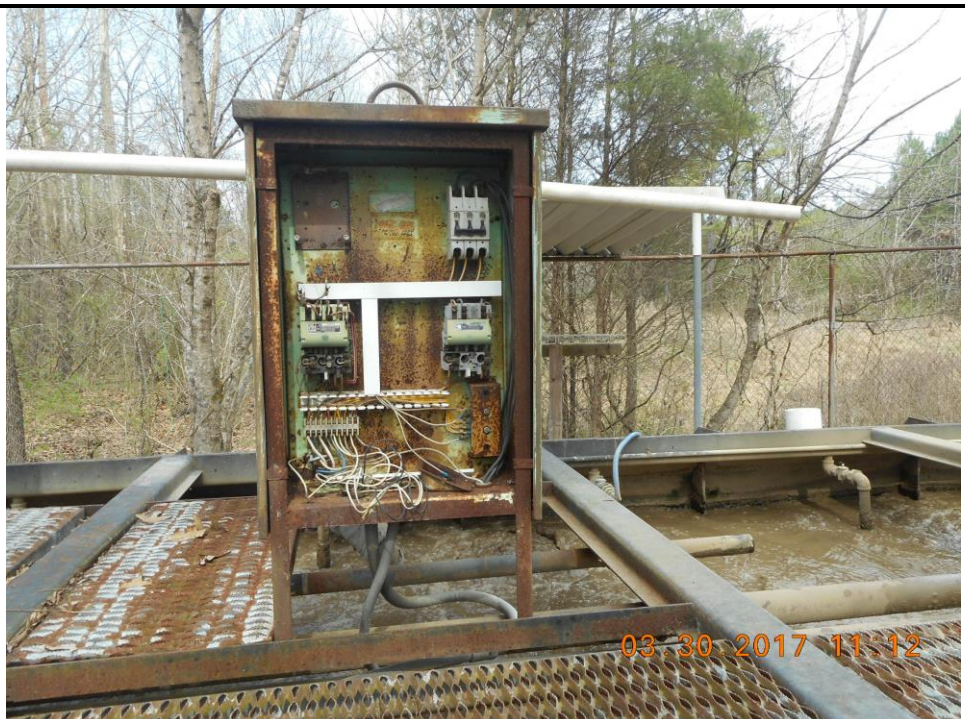
16	3-30-2017		
Description Electrical panel for wastewater plant operation. There is no cover and the electrical wires are exposed. Photo taken from inside the perimeter fencing from the east side of the aeration basin facing west.

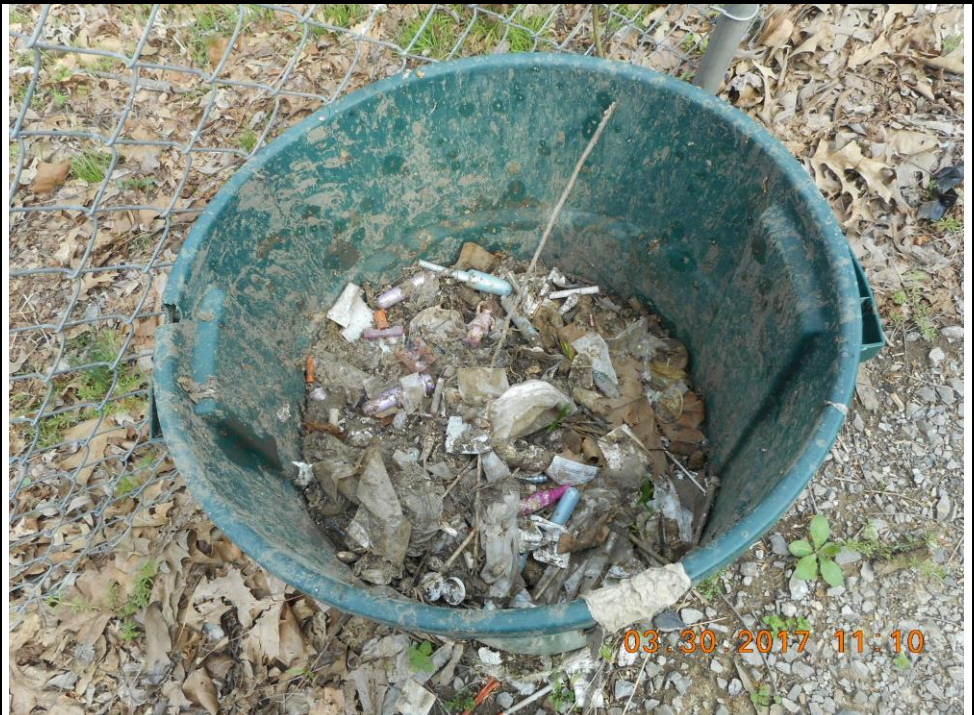
Description Wastewater screenings container located near the west perimeter fencing. The container is open and exposed to stormwater. Photo taken from inside the perimeter fencing from the east side of the container facing west.

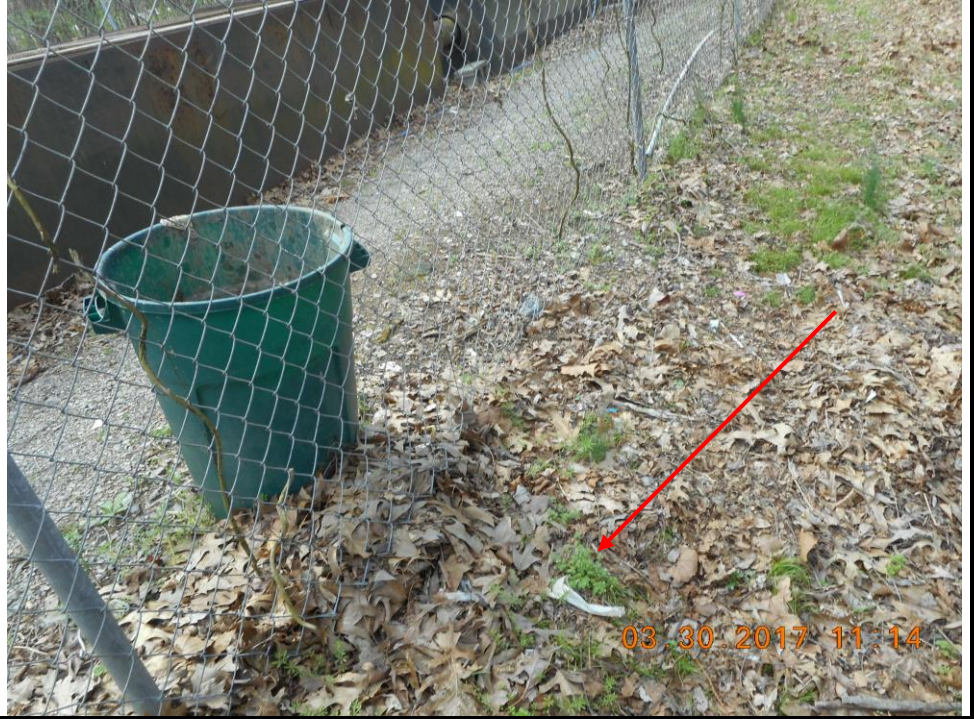
Facility Name:		Site Location:	Project No.:
Park Avenue Hotel Group Tennessee LLC aka Athens Lodge, Red Roof Inn		115 CR-247 Athens, TN	TN0028886
Photo No.	Date		
21	3-30-2017		
Description Screenings from wastewater plant outside the perimeter fencing west of the screenings container indicated by red arrow. Photo taken from outside perimeter fencing from the northwest facing southeast.

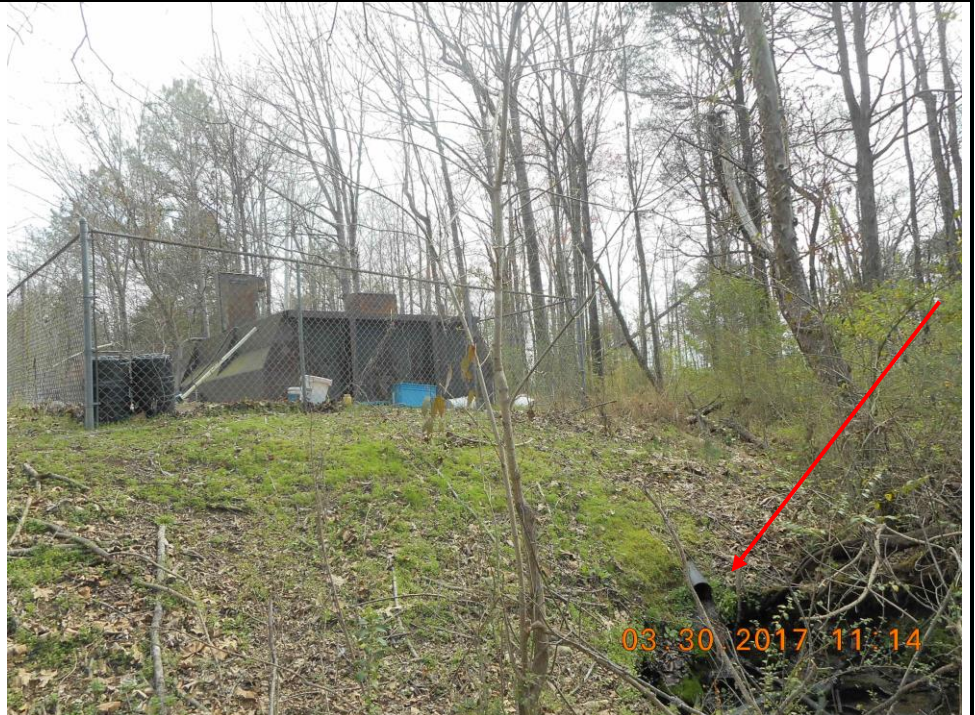
Photo No.	Date		
22	3-30-2017		
Description Outfall pipe indicated by red arrow discharging. Photo taken from southwest of the discharge pipe facing northeast.

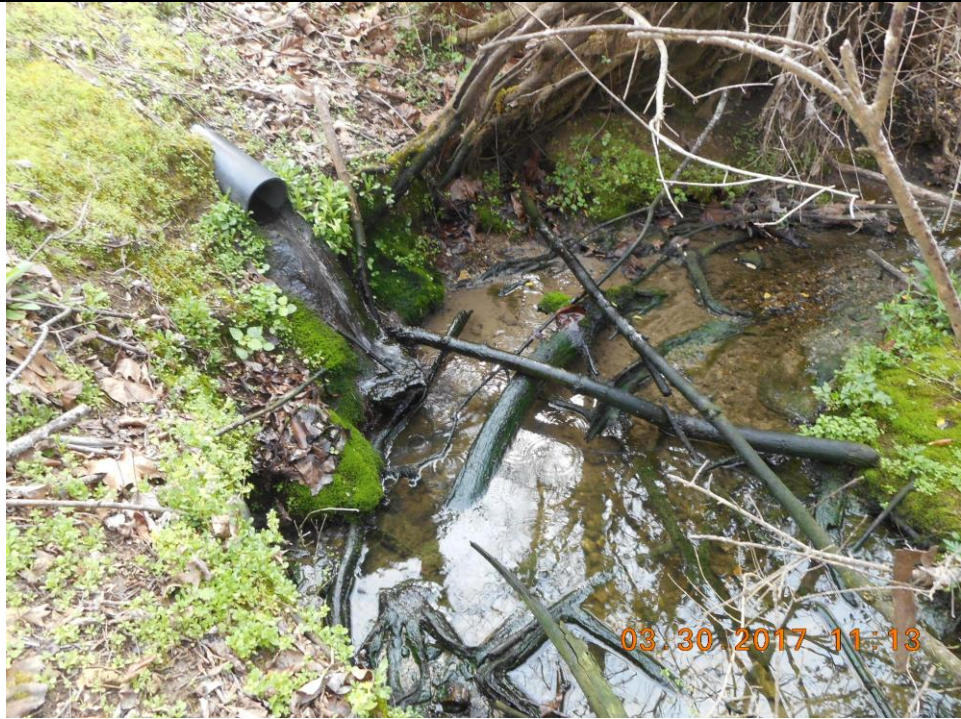
Facility Name: Park Avenue Hotel Group Tennessee LLC aka Athens Lodge, Red Roof Inn		Site Location: 115 CR-247 Athens, TN	Project No.: TN0028886
Photo No. 23	Date 3-30-2017

Closer view of outfall pipe discharging. Photo taken from southwest of the discharge pipe facing northeast.
